Manhole Inspection Summary

Manhole # S17K__047MH

Location Address: **2308 FREDERICK AV**

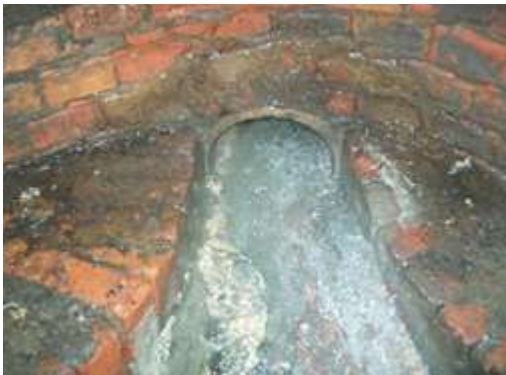
Defect 2

Infiltration: ☐ None ☐ Joint ☐ Cracks ☐ Mortar ☐ Roots ☒ **Wall**

Barrel Wall Infiltration

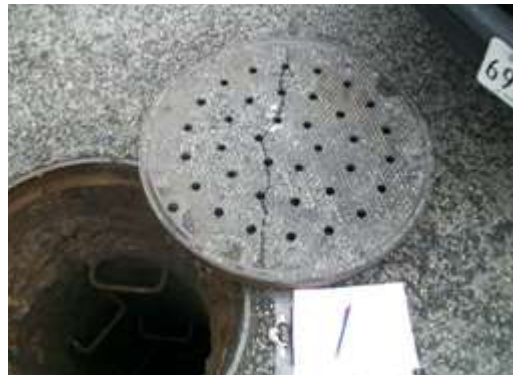
Defect 1

Comments **CRACKED MISLABLED COVER**

Condition: **Cracked**

CRACKED COVER

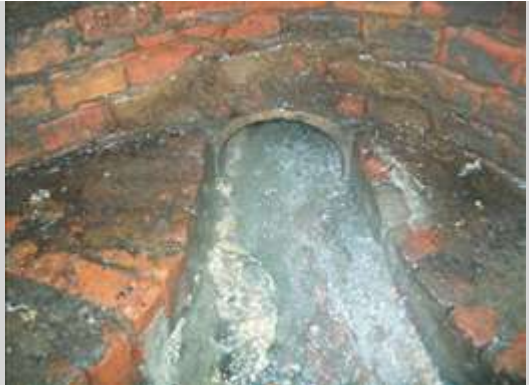
12 O'Clock Outflow

Pipe Height: **8.4** (in.) Rod and Bar (Angled)
Pipe Material: **Clay** ☐ Pipe Lined
Invert Depth: **10.60** (ft.) Flow Characteristics: **Fast**
Deposits: ☒ None ☐ Mud ☐ Sludge ☐ Debris ☐ Grease
Silt Depth: **0** (in.) Deposits Extent:
Infiltration: **Weeper** Pipe Seal Cond: **Cracked**

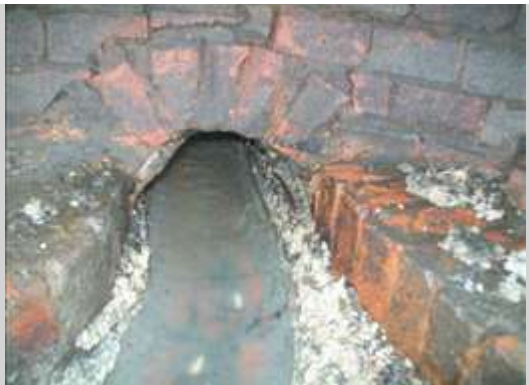
3 O'Clock Inflow

Pipe Height: **8.4** (in.) Rod and Bar (Angled)
Pipe Material: **Clay** ☐ Pipe Lined
Invert Depth: **10.56** (ft.) Flow Characteristics: **Slow**
Deposits: ☐ None ☐ Mud ☐ Sludge ☐ Debris ☒ Grease
Silt Depth: **1.5** (in.) Deposits Extent: **Light**
Infiltration: **None** Pipe Seal Cond: **Broken**
